# ARCS Project Case Study

## Public Transport Authority of Western Australia (PTA) Noise Monitoring System

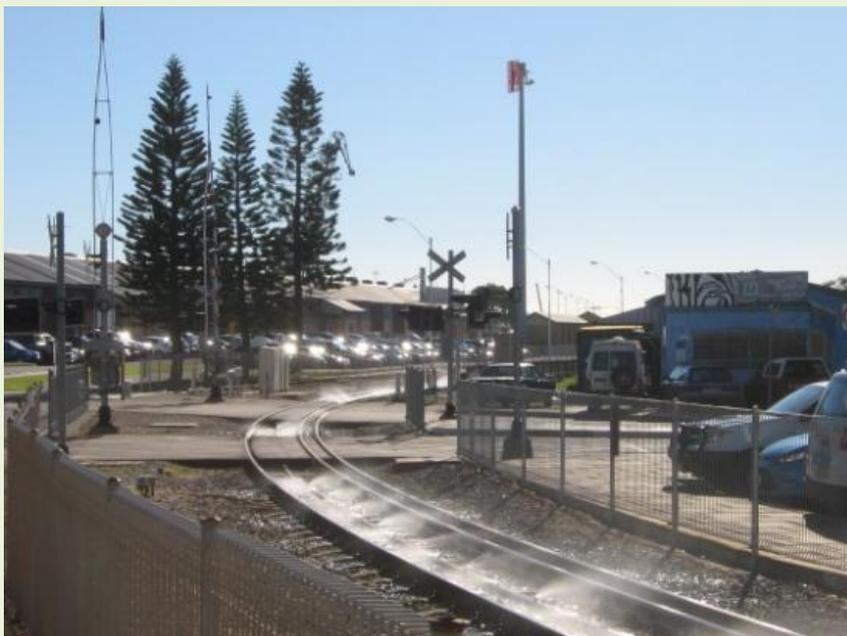
In an effort to reduce the increasing number of complaints from the local residents and the noise created by the squeal from the wheel rail interface the Public Transport Authority deployed a track watering system. The system incorporated a series of watering sprays directed onto the track and activated when an approaching train is detected.

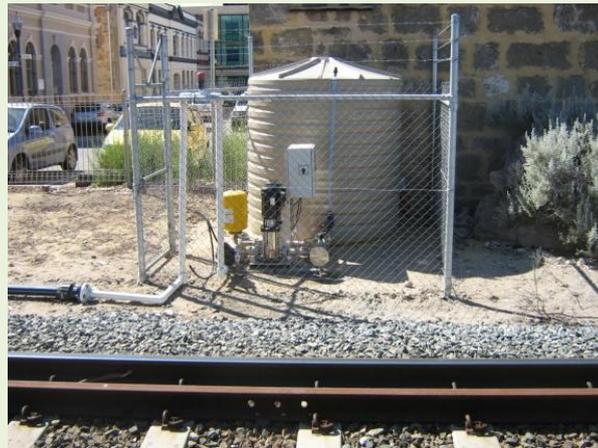
The ARCS system design was both simple and effective and involved the development of a system that monitored the watering systems and rail operation via a CCTV camera and noise recording. Footage together with the audio is stored on a locally mounted digital video recorder (DVR).

The system is remotely monitored periodically to verify correct operation by downloading archived clips of the passing trains. The maintainer is able to see the train and the watering system in operation and determine from the audio and CCTV whether the system is operating correctly and / or requires maintenance.

The system detects approaching trains using magnetic switches at an approach distance of 400m and initiates a watering start at the main problem area of track. The two approach detectors and the centralised DVR and controller communicate using 3G. Footage is also accessed remotely using 3G. CCTV images and footage are recorded for each train movement.
